## **AVIATION INVESTIGATION REPORT**

**A04P0397**

### **RISK OF COLLISION**

**NAV CANADA  
VANCOUVER INTERNATIONAL AIRPORT,  
BRITISH COLUMBIA  
29 OCTOBER 2004**

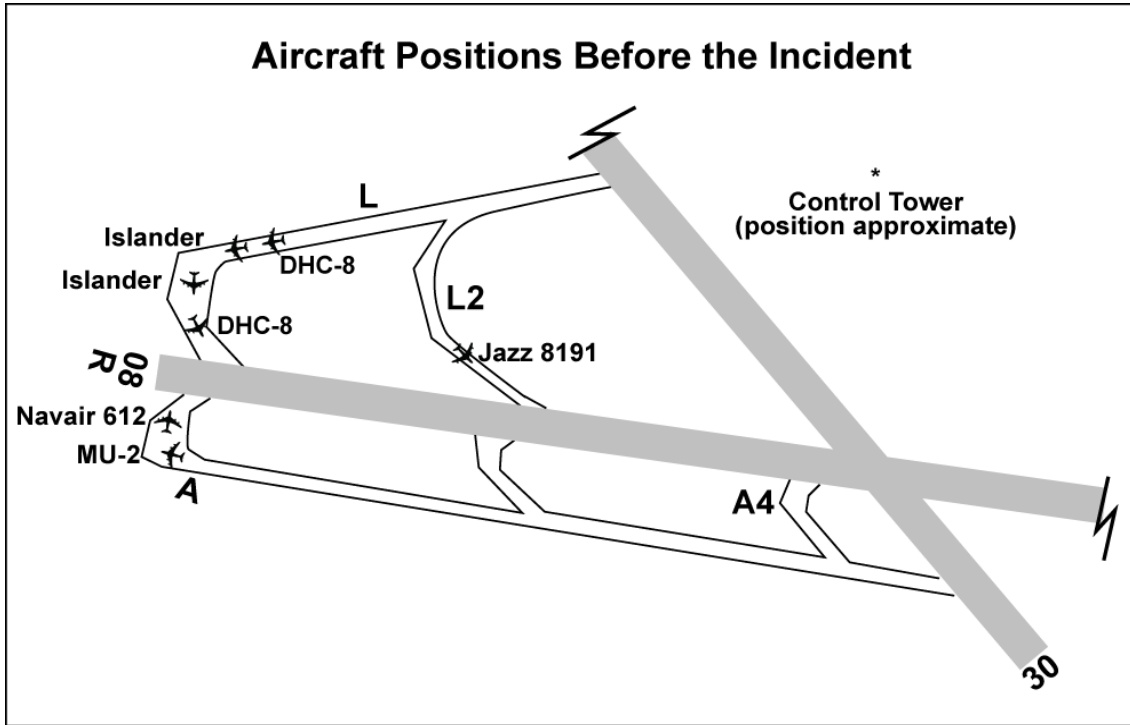
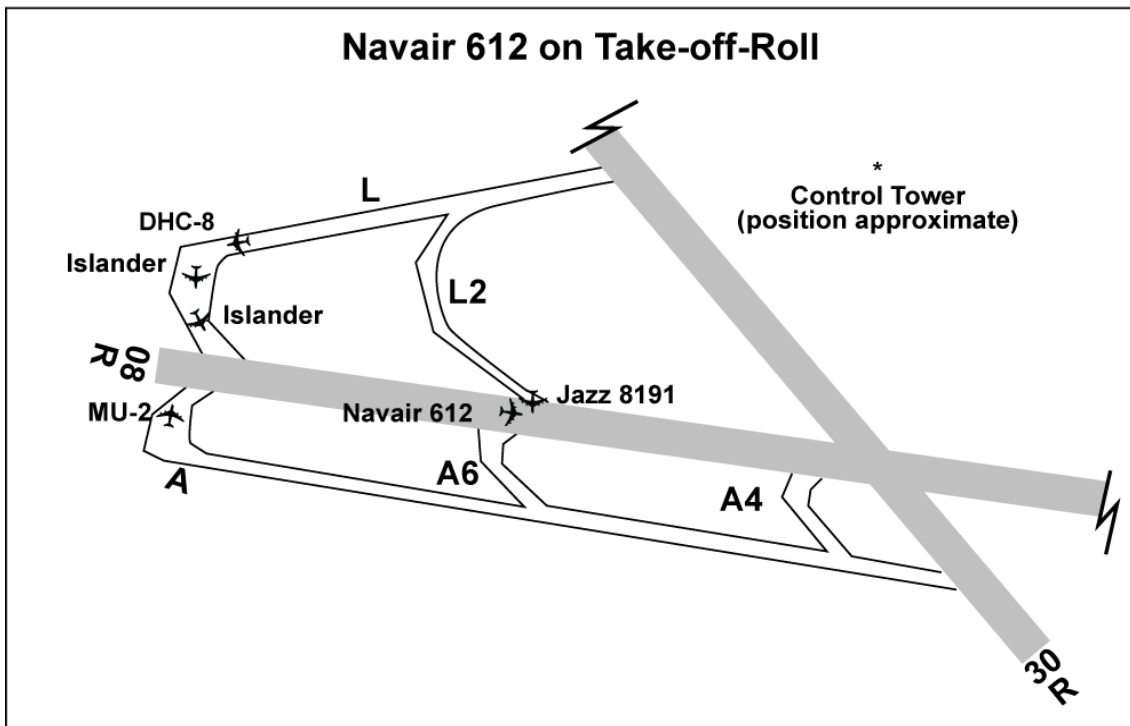
# Appendix A – Aircraft Positions

At the time of the occurrence, two arriving aircraft were on final for Runway 08R, and seven aircraft were waiting to depart on Runway 08R (see Appendix A – Aircraft Positions). Aircraft departing on Runway 08R can approach the threshold from either Taxiway A on the south side of the runway, or Taxiway L on the north side. Jazz 8191, one of the waiting aircraft, was on Taxiway L2, on the north side farther down the runway. Of the other six aircraft, four were on Taxiway L (a DHC-8, two Islanders, another DHC-8) and two were across the runway on Taxiway A (the Islander [Navair 612] and a Mitsubishi MU-2).
